## Condition Monitoring and Diagnostics of Rolling Bearings of High-voltage Electric Motors during Their Operation

Vladimir N. KOSTYUKOV<sup>1</sup>, Evgeniy V. TARASOV<sup>1</sup>

1. SPC Dynamics, 644099, Omsk, Russia, post@dynamics.ru, tarasov\_omsk@mail.ru

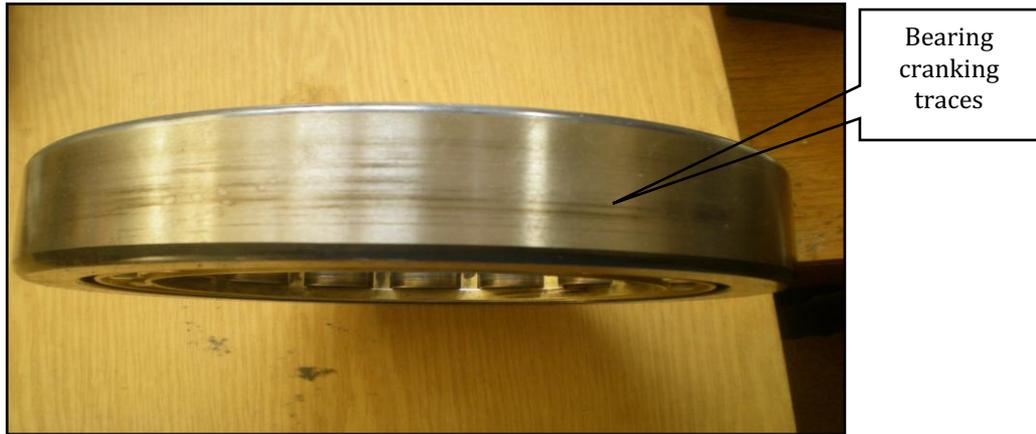
- on the outside surface of the outer ring of a tail bearing there are dark traces indicating that the bearing rotated in end shield. In addition, it shows that there is an electric discharge lesion focus (FIGURE 2a, 2b).
- on the inner surface of the cone there is a dark strip wide enough to confirm that the inner ring and the shaft of an electric motor are not in full contact throughout the whole area (FIGURE 2c). On the inner surface of the inner ring there is an electric discharge lesion focus as well. On the raceway of the inner ring there are two apparent narrow rings of inceptive defects. Fourteen rollers each have roll traces.

a) Outside surface of outer ring of electric motor tail bearing

b) Electric discharge lesion focus on the outside surface of outer ring

Thus, electric motor bearings have been changed, bearing shields and stator have been repaired. The lubrication has been changed as well.

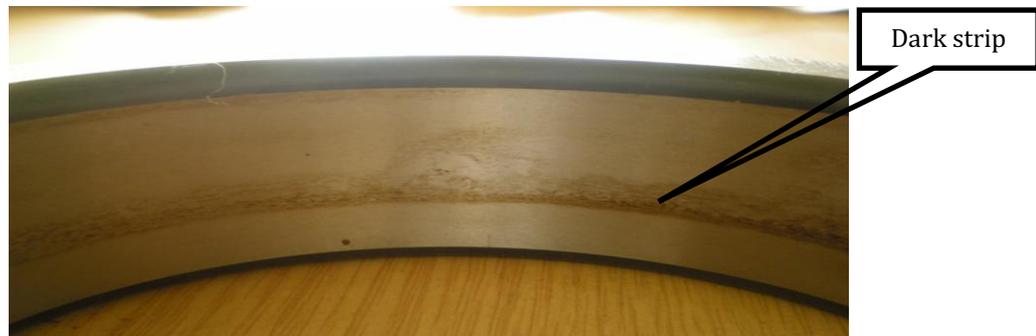
c) Inner surface of the cone of electric motor tail bearing
